RESEARCH MEMORANDUM

INVESTIGATION OF MECHANICAL FASTENINGS FOR SOLID
TURBINE BLADES MADE FROM DUCTILE MATERIALS

By André J. Meyer, Jr., Albert Kaufman, and W. C. Caywood

NACA RM E54E21

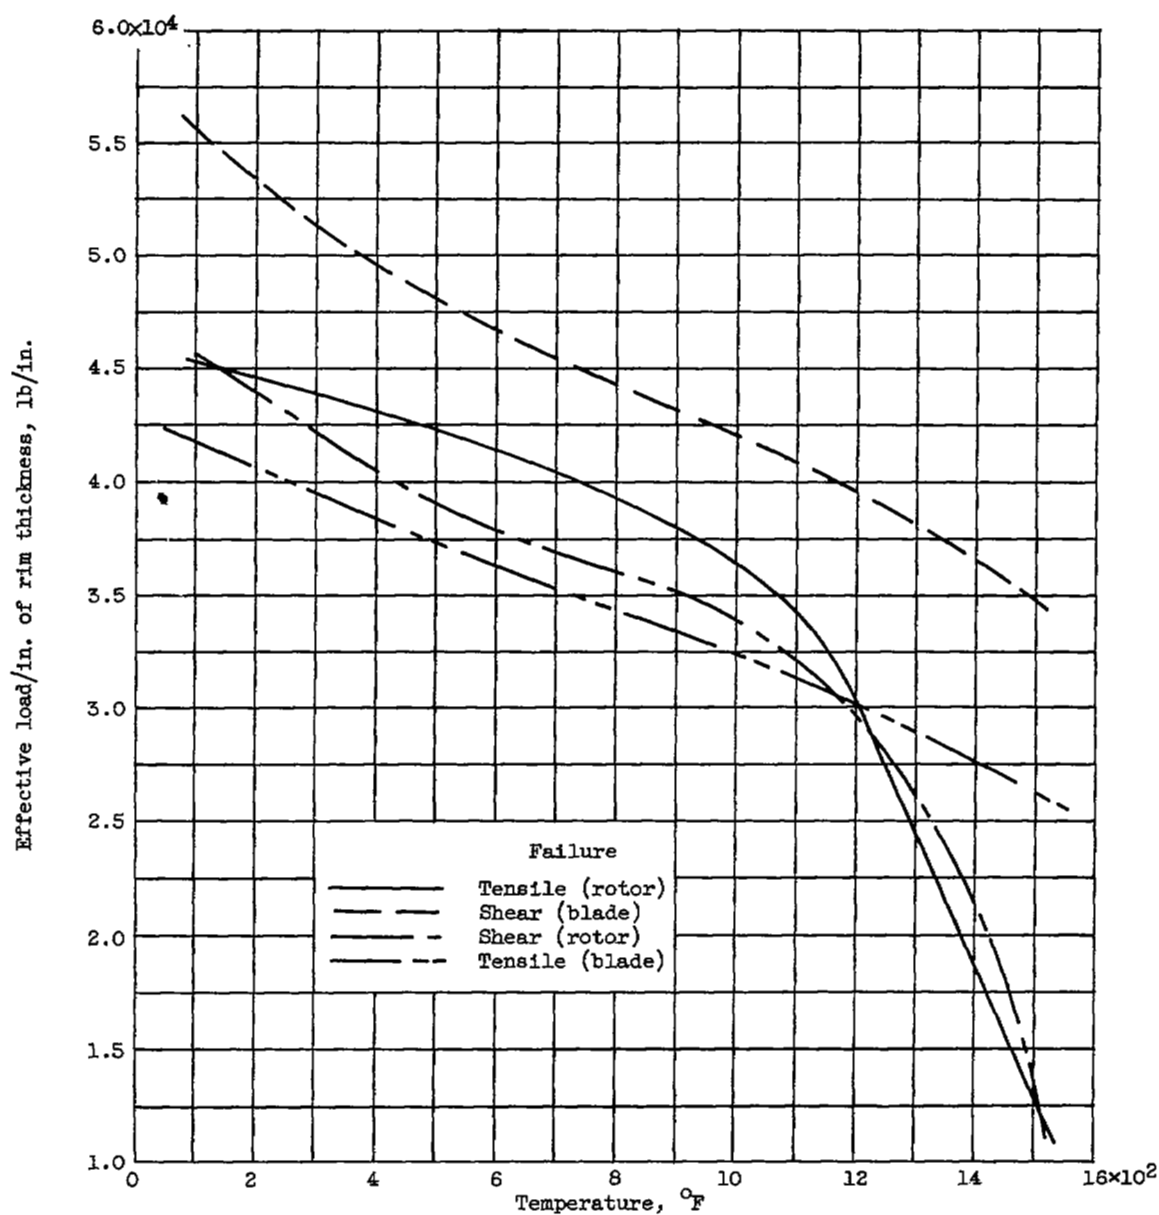
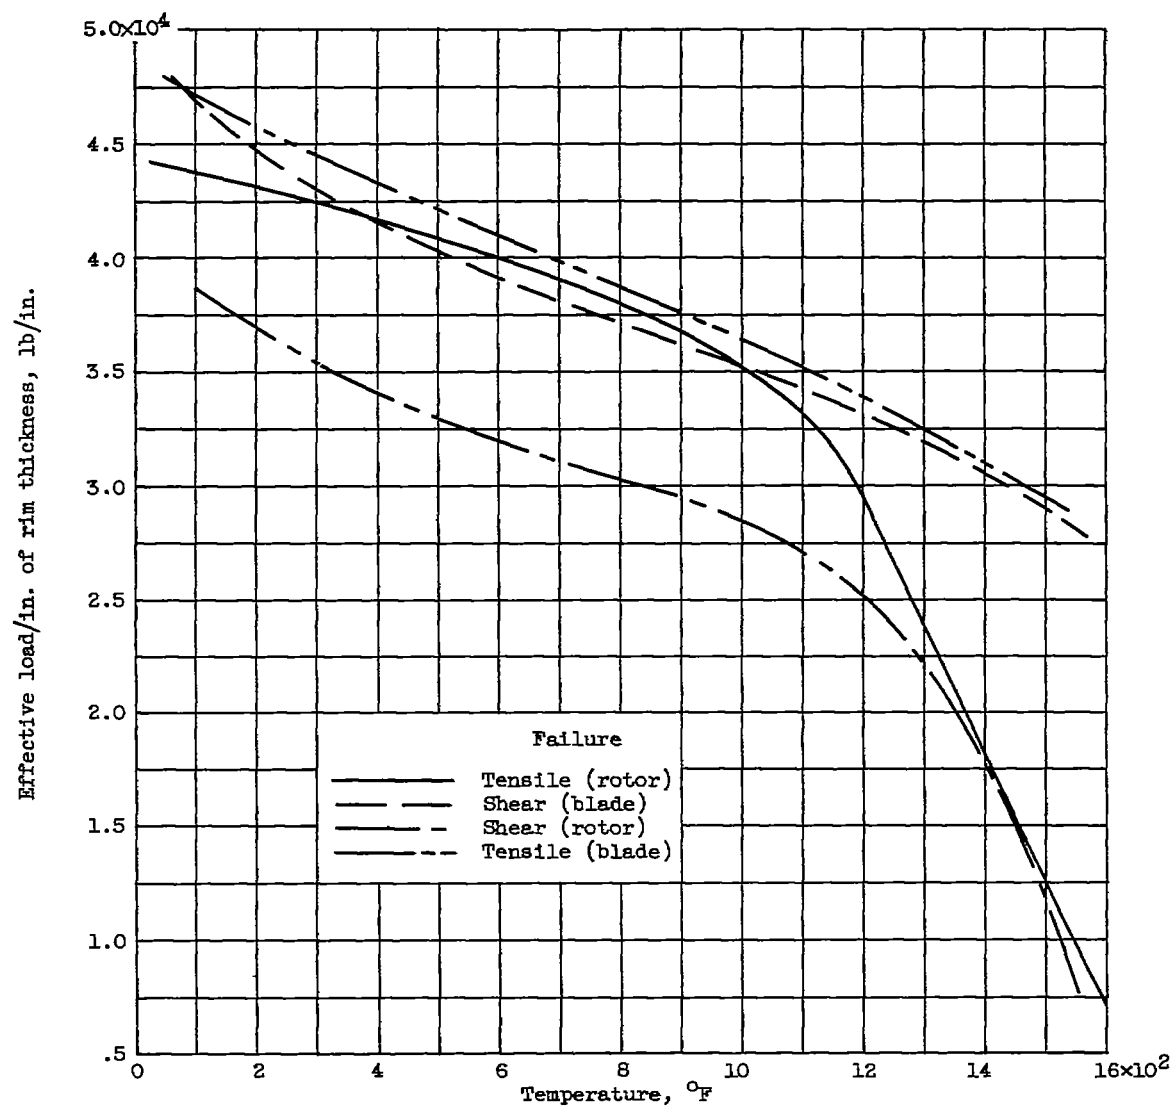
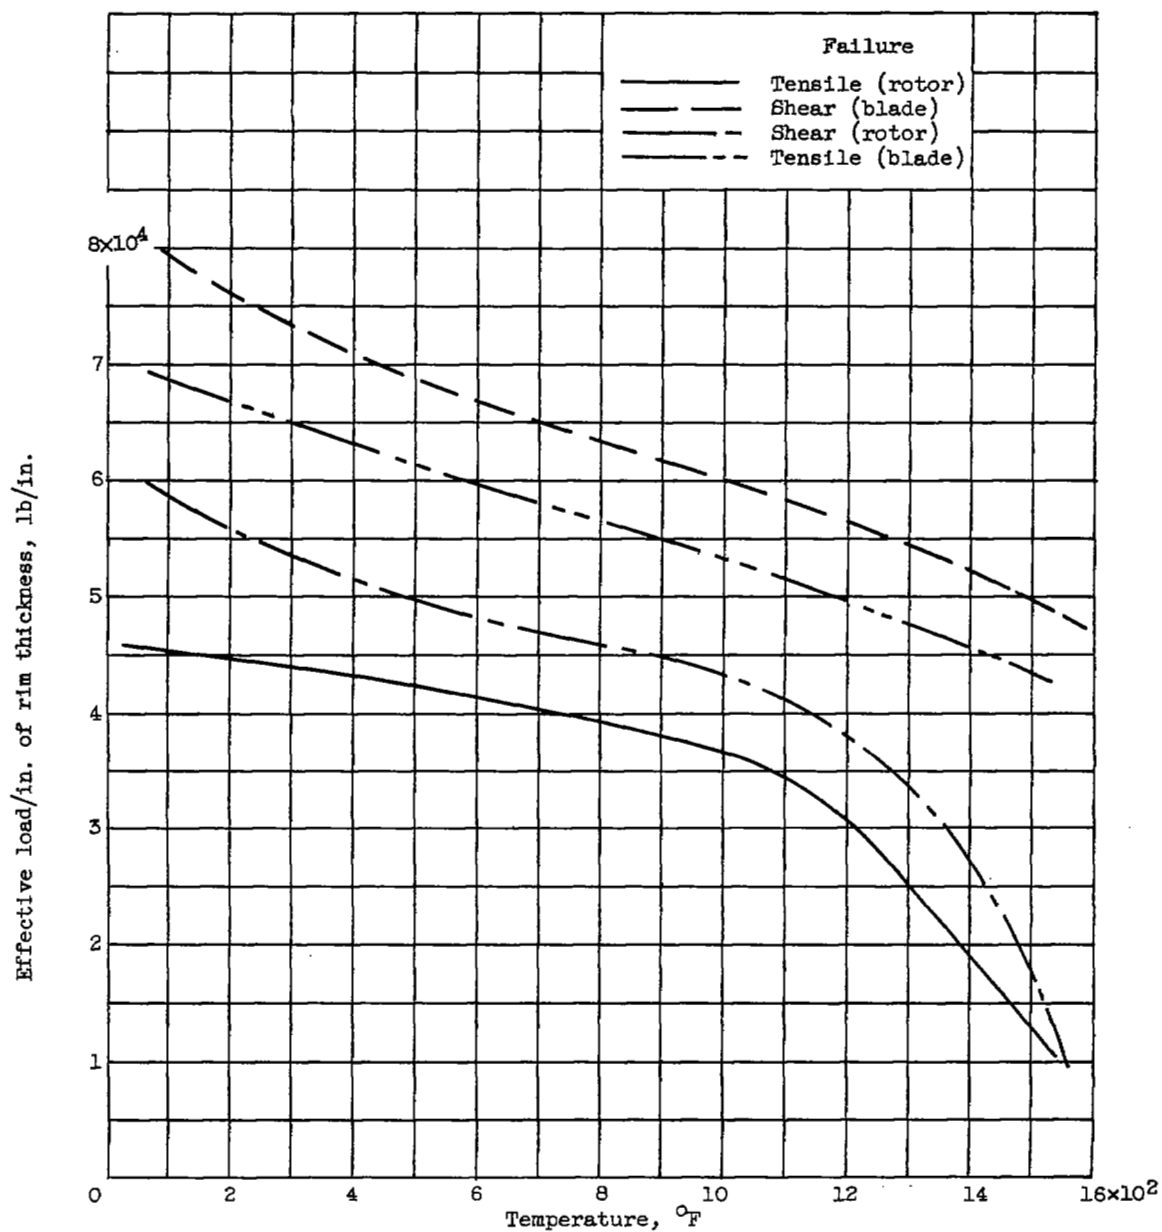
(a) Blade root A.

Figure 13. - Corrected strength data to account for centrifugal field during engine operation.

(b) Blade root B.

(c) Blade root C.

When the root specimens are subjected to a tensile load as used in the test machines, the results will correlate with figure 12. When a blade is in a centrifugal field as in the case in an actual engine, however, a correction should be applied. The rotor must carry the whole blade and, in addition, must carry the rim weight in the centrifugal field. Likewise, the rotor serrations in shear must support their own weight as well as the centrifugal load of the whole blade; and the blade serrations must carry, in addition to the airfoil, the root weight below the top serration neck minus the blade serration weight beyond the shear plane. Computed correction factors are presented in table II. These correction factors were applied to (divided into) the data of figure 12 to obtain figure 13. Thus, in an engine, blade A (fig. 13(a)) would again have a shift in failure mechanism, but the transition would be one from tension in the blade root to tension in the rotor root instead of shear of the rotor serrations. At 1200° F the failure might be either these types or shear of the rotor serrations, since all three lines intersect proximately.

In the engine, blade root B (fig. 13(b)) would probably again fail in shear of the rotor teeth throughout the temperature range, although above 1300° F the effective rotor strength in tension decreases to approximately the magnitude of the effective shear strength. Blade C in a centrifugal field should fail consistently in tension of the turbine rotor at all root temperatures below 1550° F, according to figure 13(c).

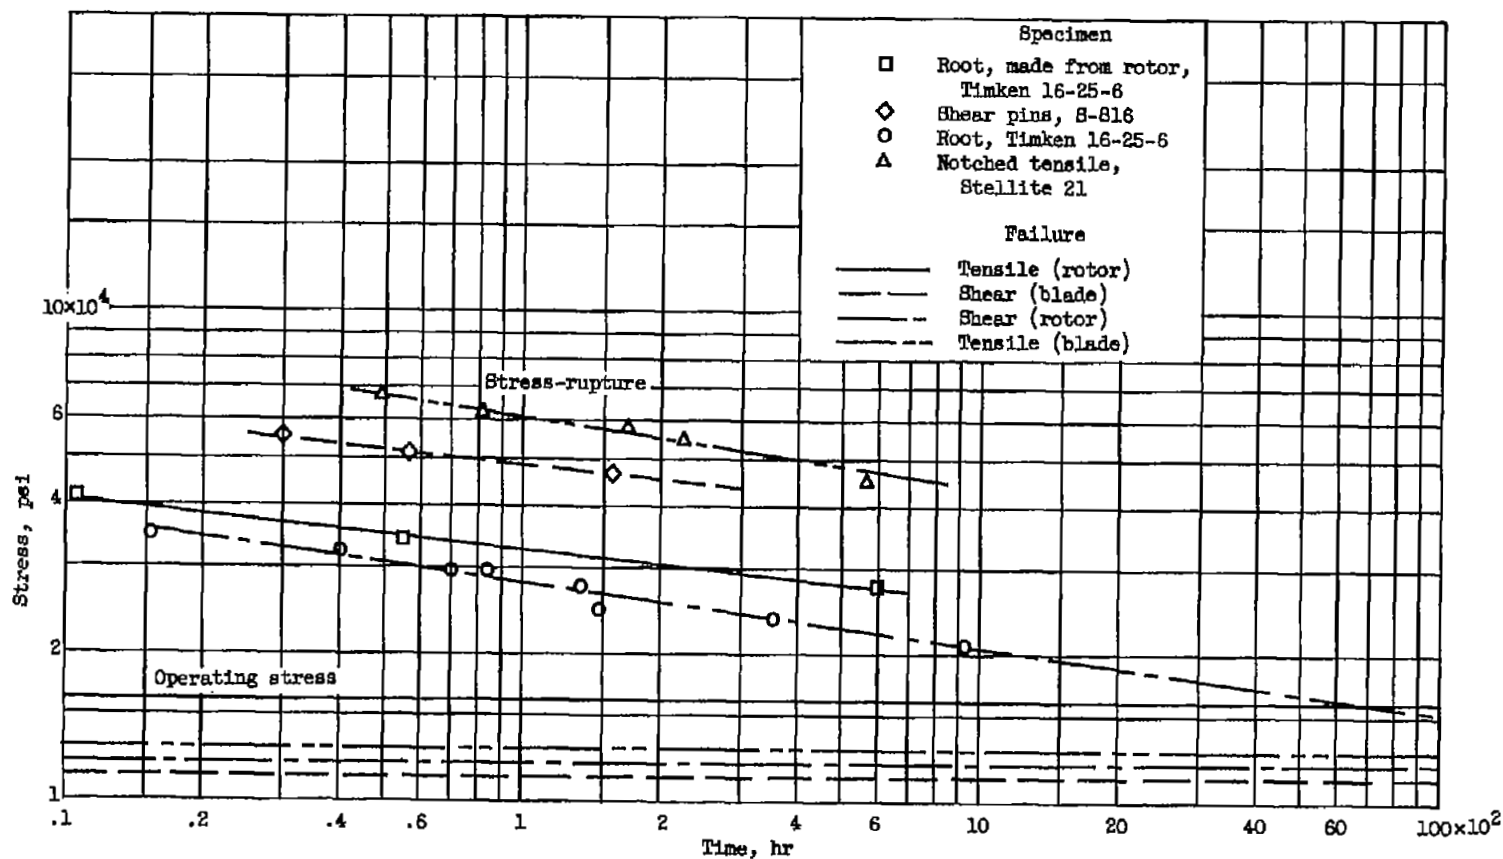
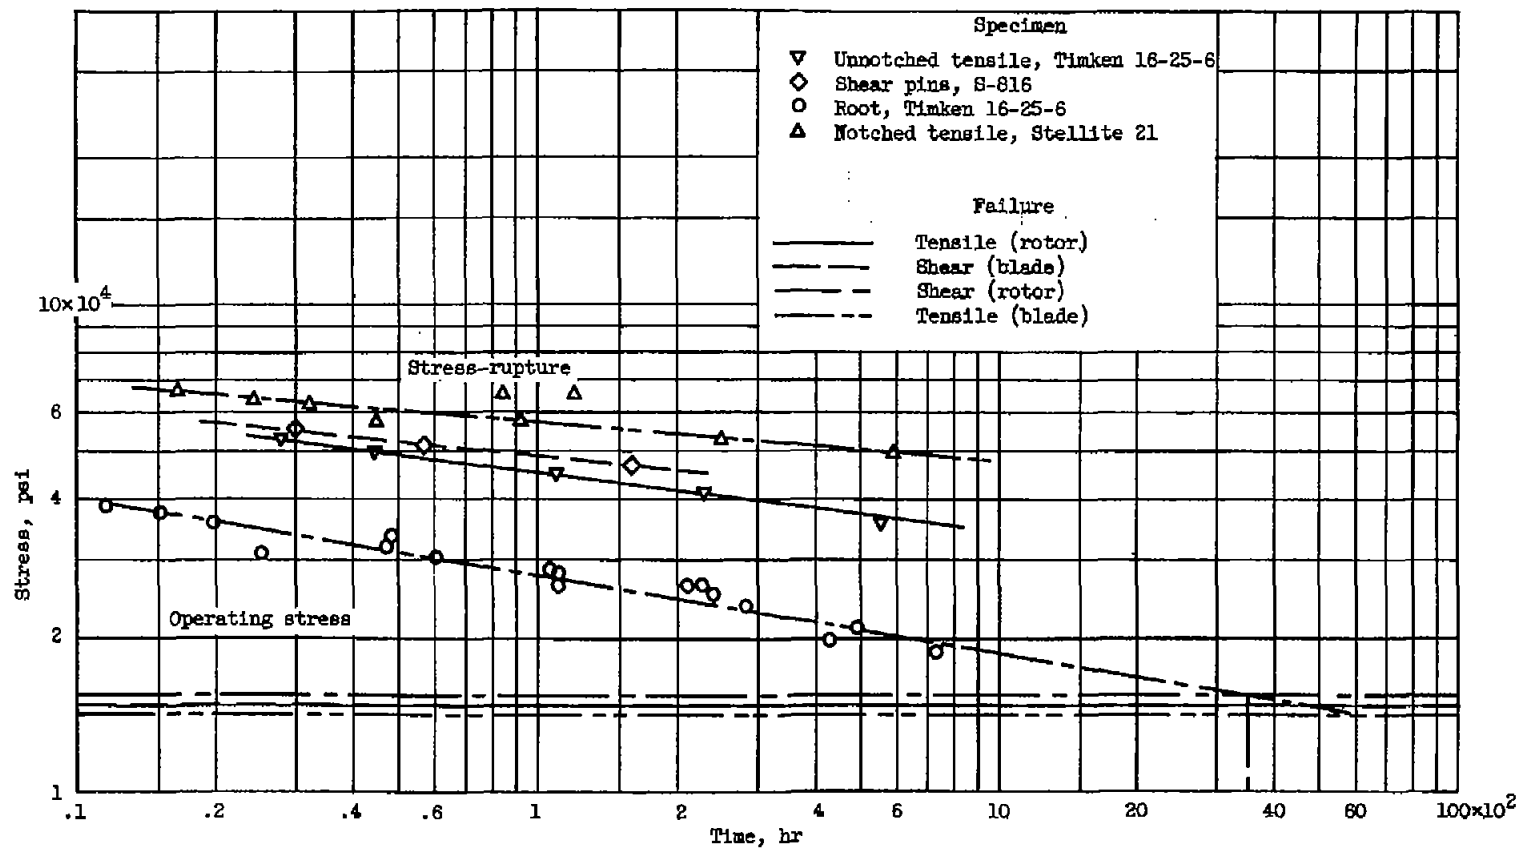
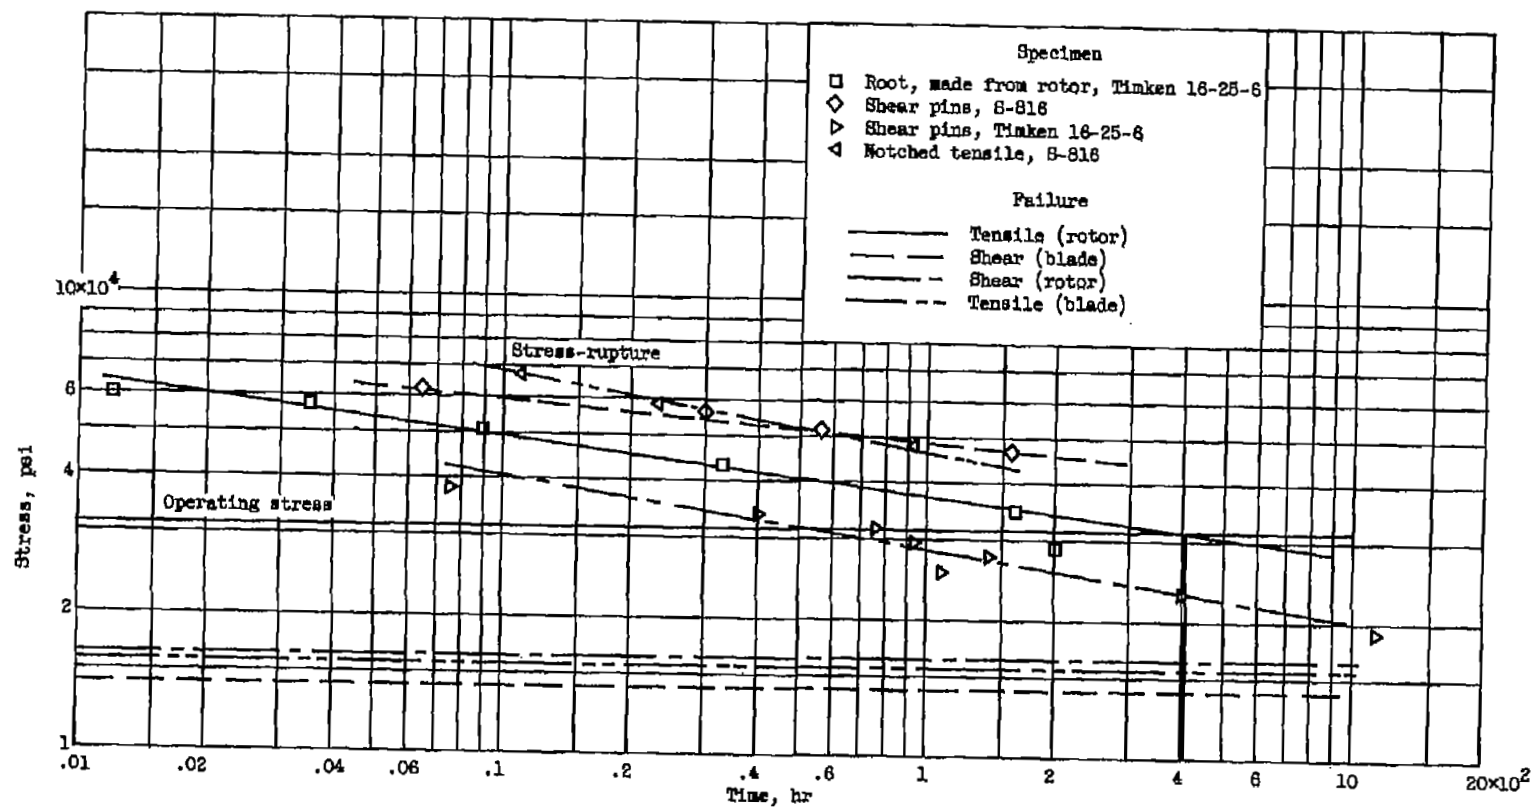
(a) Blade root A.

Figure 14. - Stress-rupture results determined at 1200° F.

(b) Blade root B.

(c) Blade root C.

The maximum rim temperature measured in reference 5 at rated speed was 1200° F. Therefore, a series of long-time tests at 1200° F was made with the three fir-tree root configurations. The results are presented in figure 14. Also included in the figure are operating stresses for the four critical regions of the fastening. The point of intersection of the horizontal operating-stress lines and the inclined lines through the stress-rupture data points indicates the maximum life expectancy at the rated-speed condition. Actual service life would be

The mean life of blade A (fig. 14(a)) would be well over 2000 hours, and the failure mechanism should be one of shear of the turbine rotor serrations. Blade B (fig. 14(b)) has a much shorter life at rated speed, and the failure mechanism is again one of shearing of the rotor serrations. Blade C (fig. 14(c)) has a still shorter life, totaling 400 hours, but the rotor segment between blades should fail in tension across the bottom pair of serrations. Therefore, all failures of the roots investigated should occur in the rotor. In service, tensile failures occasionally occur in the blade root, whereas the data presented show a conservative safety factor in the blade root both in tension and shear. This discrepancy is logically explained by the presence of vibrations that cannot be predicted accurately.

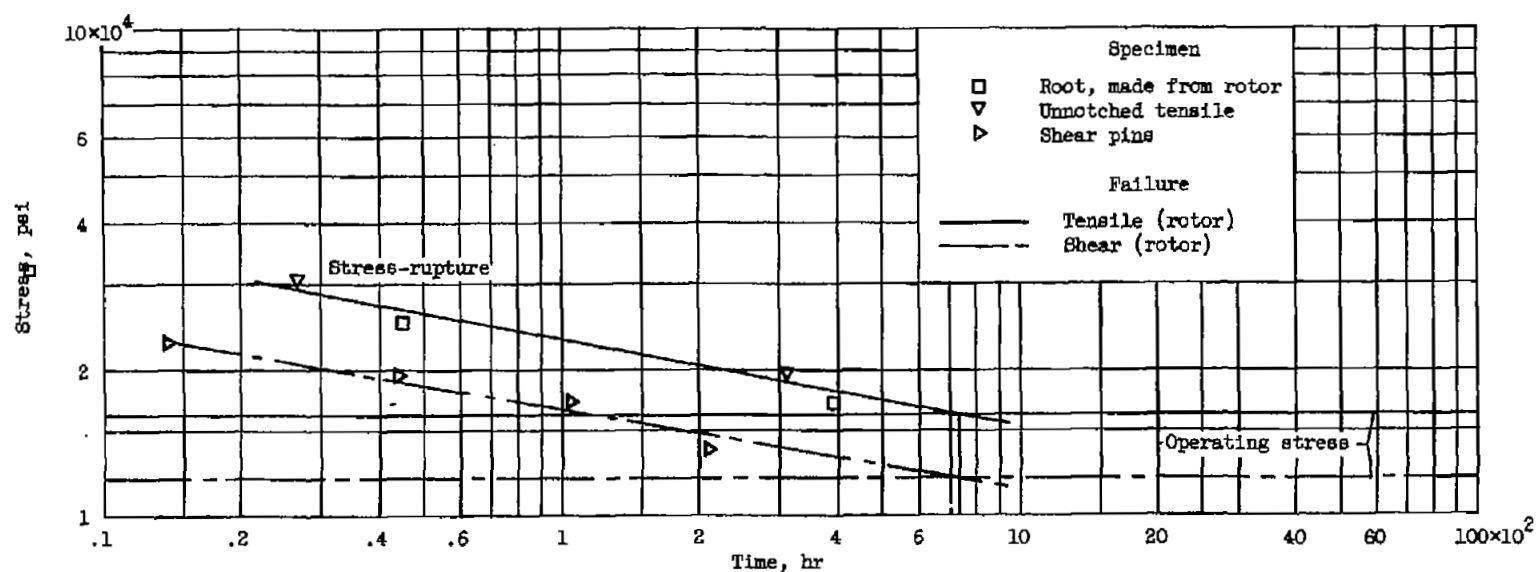
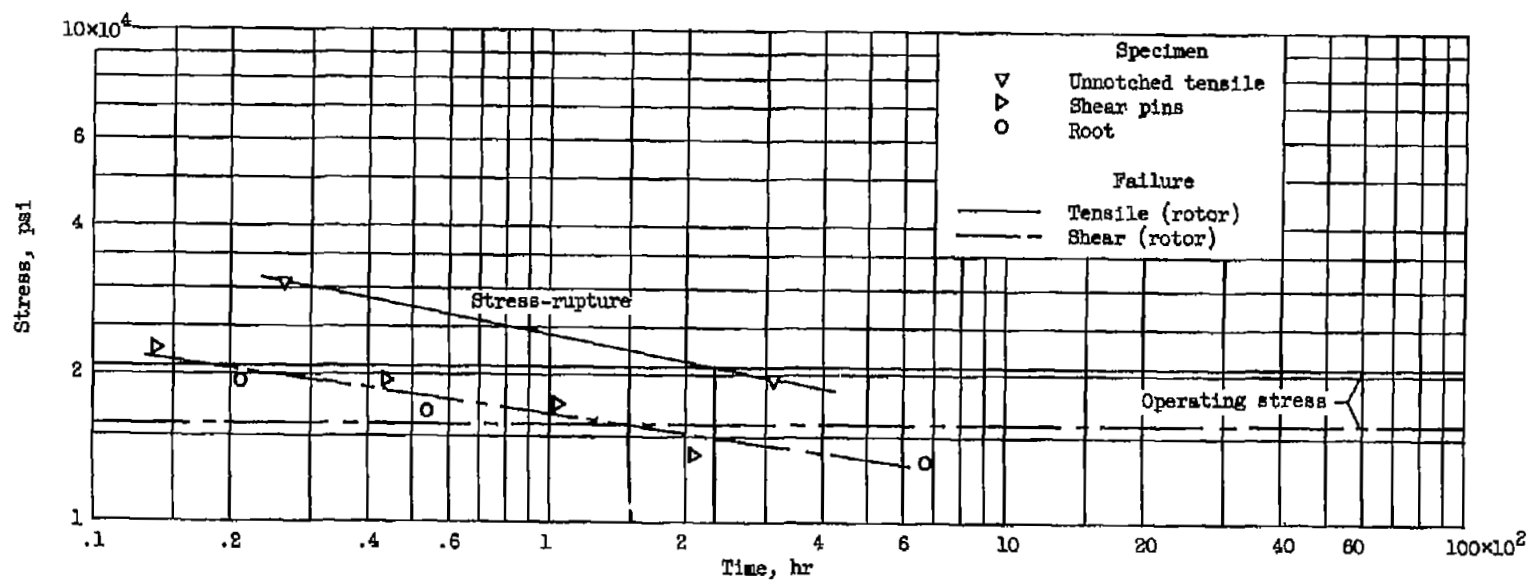
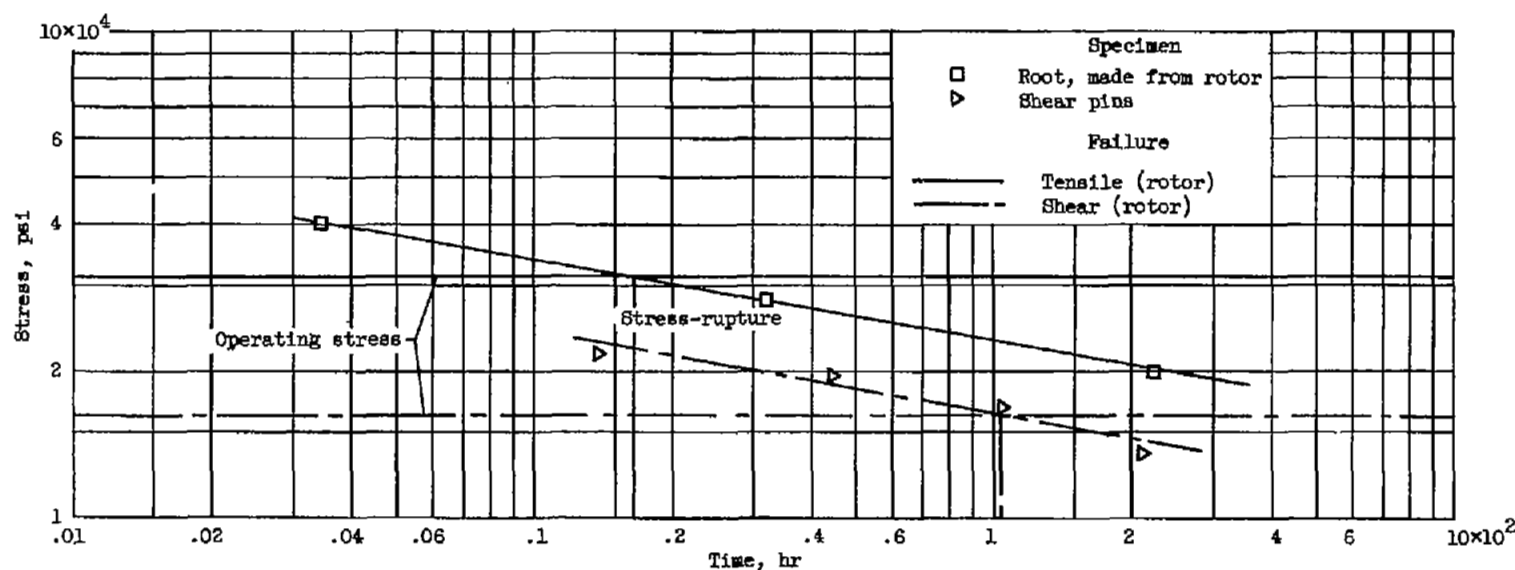
(a) Blade root A.

Figure 15. - Stress-rupture data for turbine rotor at 1350° F. Specimens of Timken 16-25-6.

(b) Blade root B.

(c) Blade root C.

Turbine rotor A has sufficient strength at the higher temperature and could be used without alteration, provided the blade airfoil can either withstand the increased temperature or can be cooled by some method (fig. 15(a)). The life, however, is reduced from well over 2000 hours to 700 hours. Rotor B (fig. 15(b)) also would be suitable for limited life at the higher temperature, its life being reduced to 150 hours at rated-speed conditions. Blade root C (fig. 15(c)) would be applicable only for short life or for expendable missile service at 1350° F rim temperature without a major redesign. The mean life is 16 hours, compared with 400 hours at 1200° F rim temperature, or a ratio of 25:1. If a higher constant shear stress of 20,000 psi is assumed for both temperatures for blade roots A and B, so that extrapolation becomes unnecessary, the ratios of life for 1200° to 1350° F are 40:1 and 33:1, respectively. The mechanism of failure at 1350° F is still one of shear of the serrations for roots A and B and again one of tension across the rotor serrations for root C.

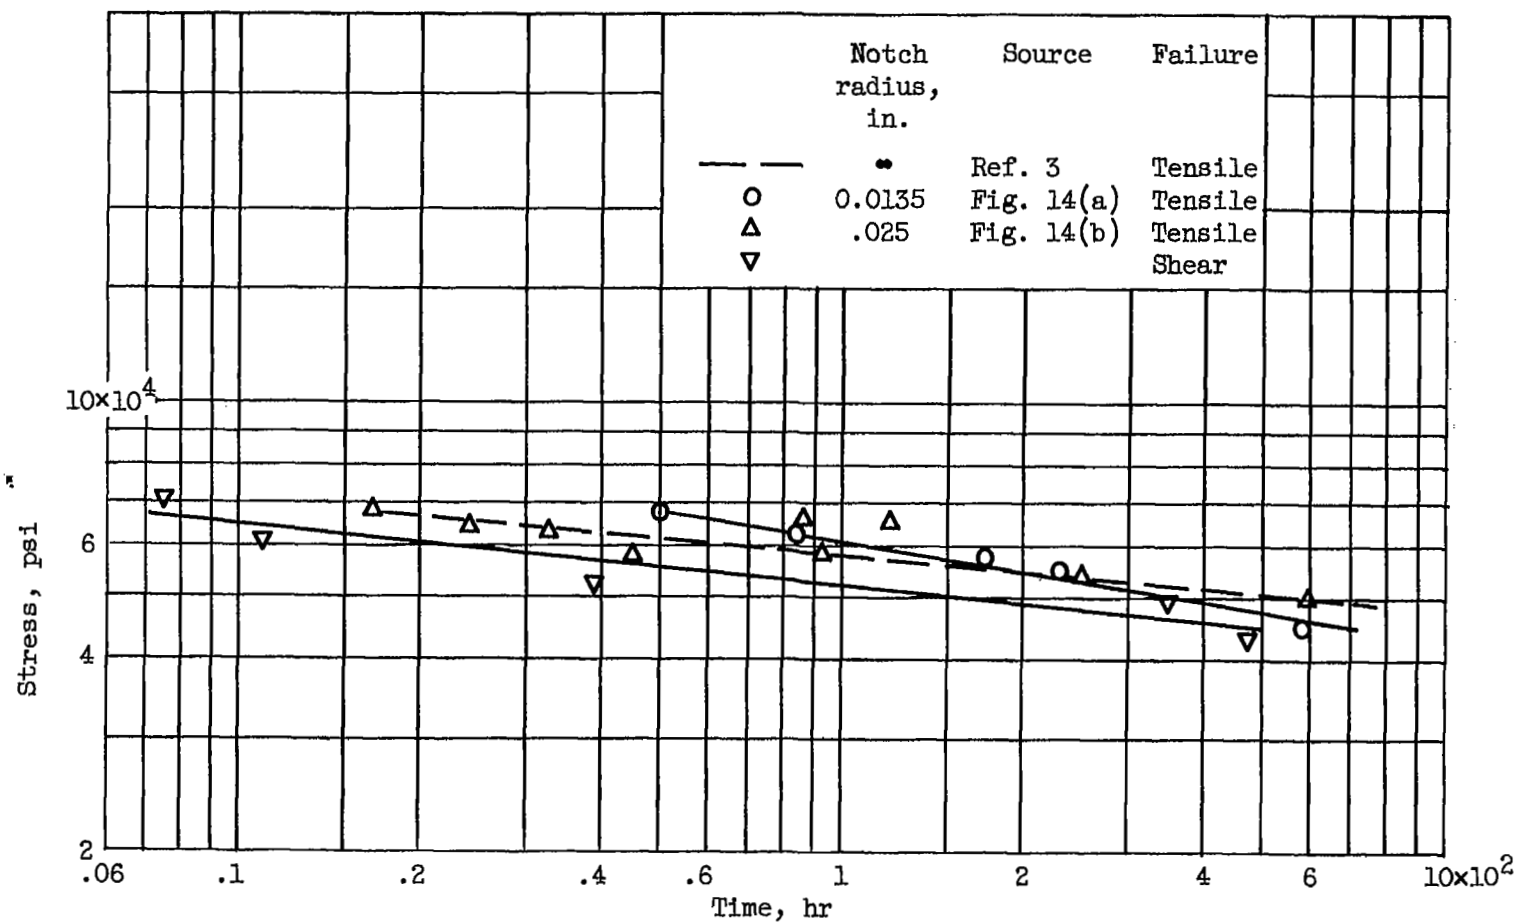
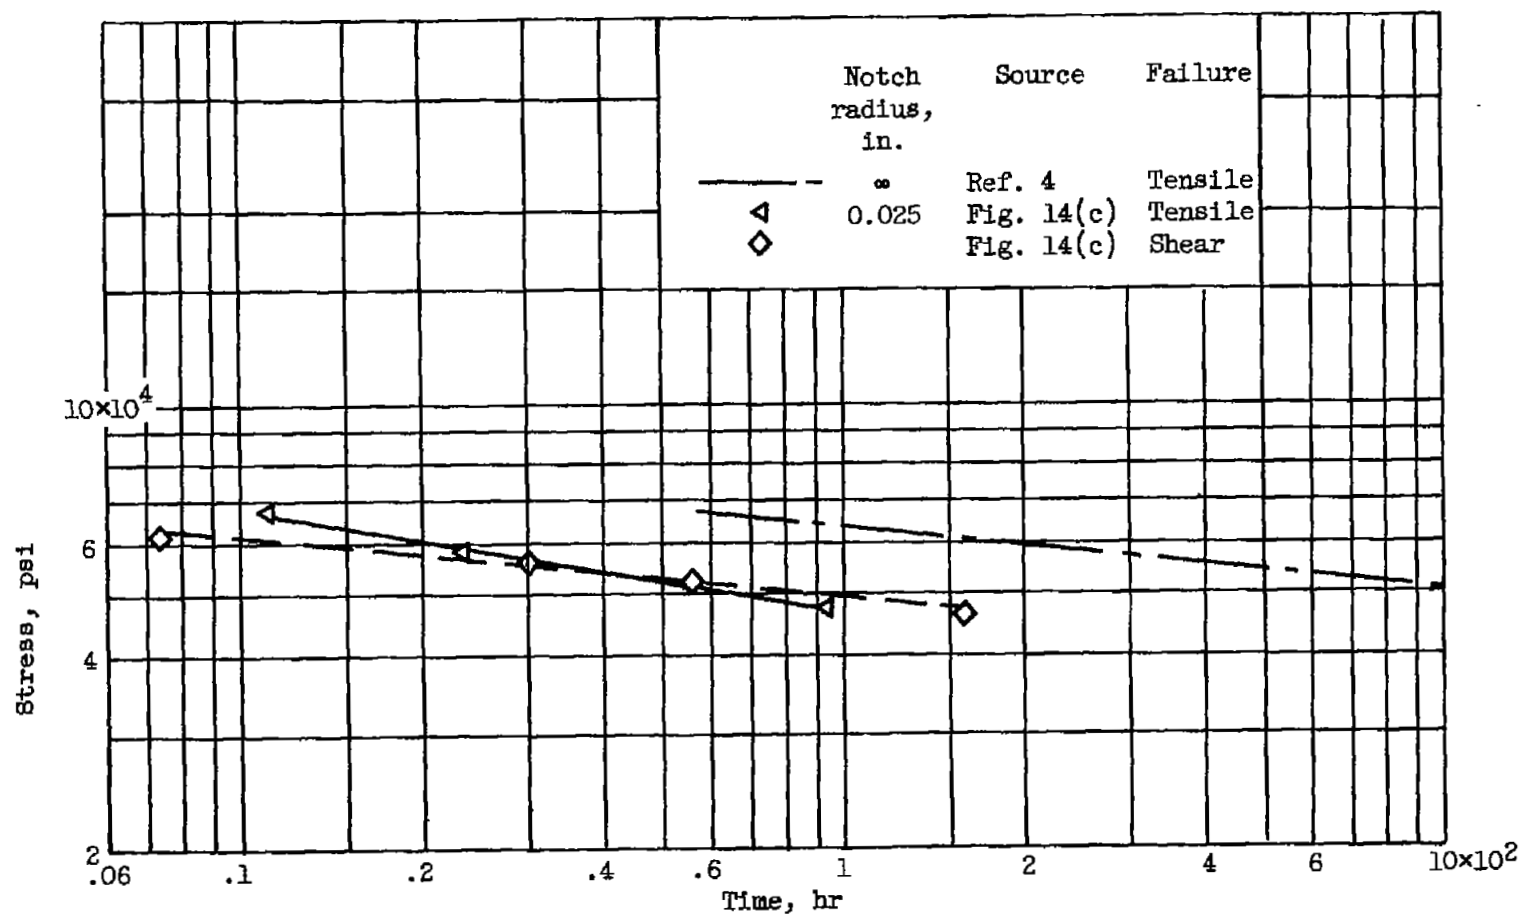
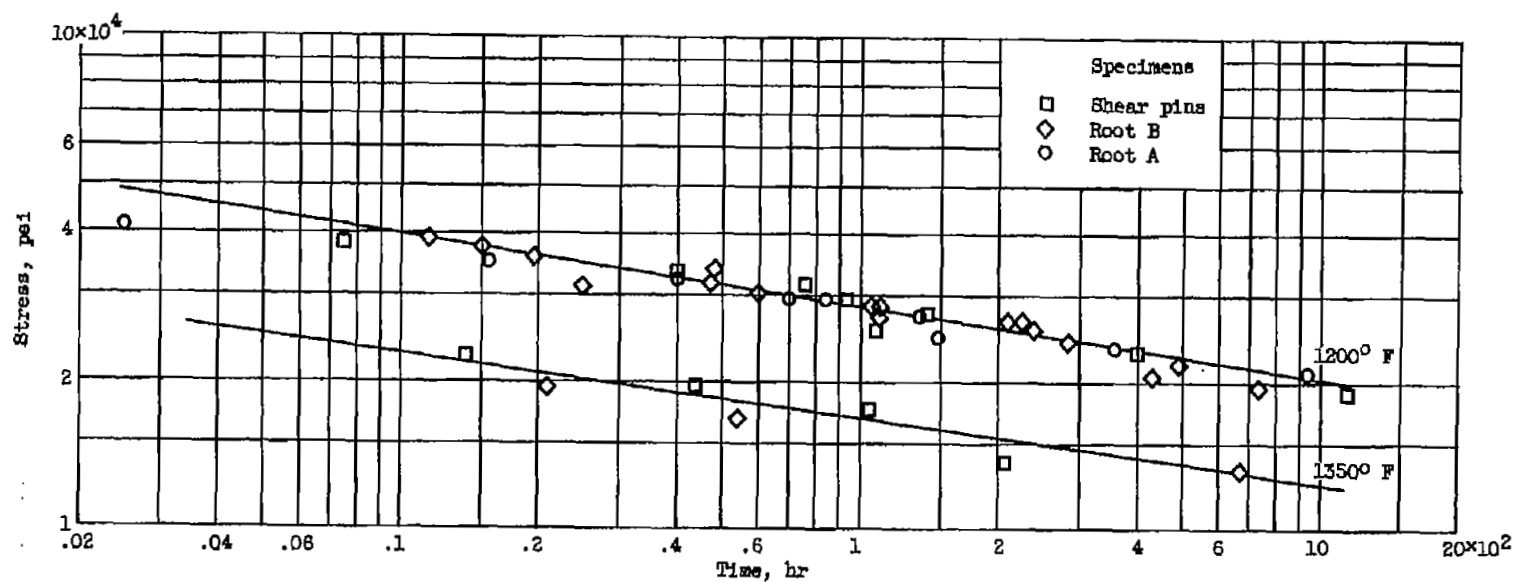
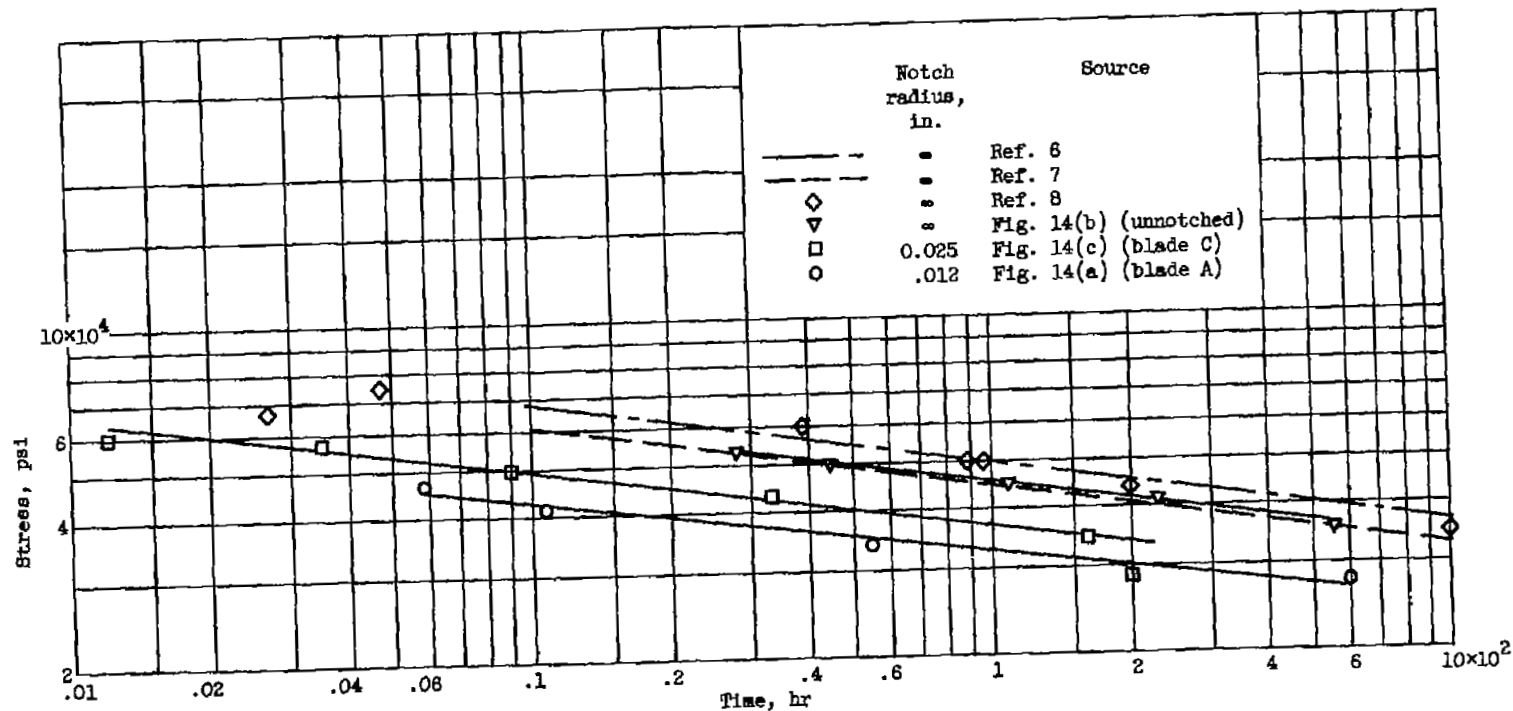
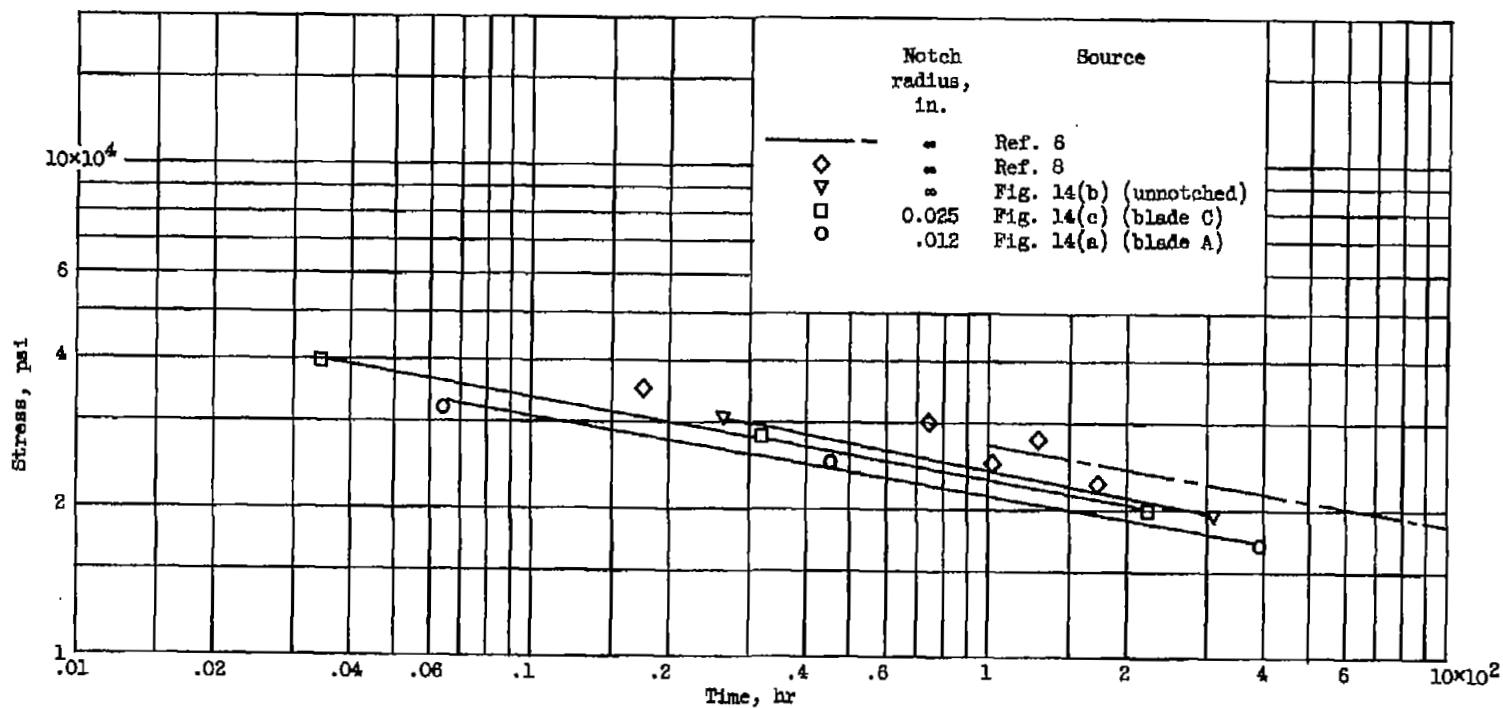
(a) Tensile properties of Stellite 21 at 1200° F.

Figure 16. - Effect of serration fillet radius on stress-rupture properties of turbine blade and rotor materials.

(b) Tensile properties of S-816 at 1200° F.

(c) Shear properties of Timken 16-25-6 at 1200° and 1350° F.

(d) Tensile properties of Timken 16-25-8 at 1200° F.

(e) Tensile properties of Timken 18-25-6 at 1350° F.

By replotting some of the data of figures 14 and 15 so as to compare like failure mechanisms for the three different roots, some interesting correlations are derived. In figures 16(a) and (b) the rupture data for the blade materials are compiled along with data from several references.

The casting alloy, Stellite 21, from which many of the root specimens were made, is apparently insensitive to notches with fillets down to 0.0135-inch radius (fig. 16(a)). The S-816, however, from the limited data obtained, is greatly affected (fig. 16(b)). Evidently, each turbine blade material must be independently evaluated to determine the proper mechanical properties to be used in root design.

For the rotor material, assuming the shear data as obtained from the simple pin test at both 1200° and 1350° F were sufficiently accurate to use for design basis, the shear areas chosen for computations are apparently correct, as indicated by the close agreement between pin and root shear data plotted in figure 16(c). Serration fillet radius had no effect on the shear properties, as indicated by the roots of different radii. The long-time tensile properties of the rotor material, however, are affected by fillet radius as shown in figures 16(d) and (e). The effect is more pronounced at 1200° than at 1350° F. The unnotched NACA tensile data for Timken 16-25-6 agree very well with the tensile data obtained from specimens cut from turbine disks (ref. 7).
